Property Inspection Report

123 Main St., Unit 5555, Smalltown, NJ 12345

4/24/2010 10:00 am

Report File: Townhouse Sample

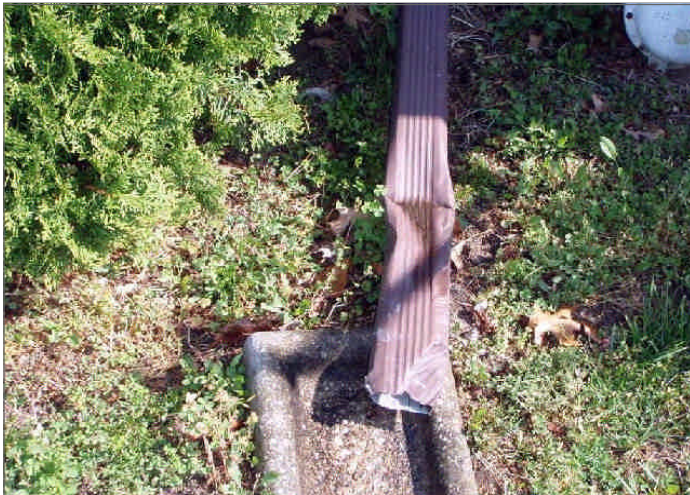
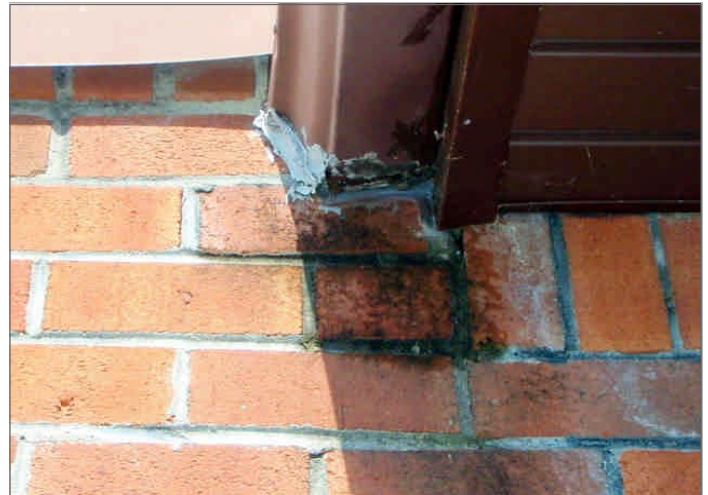
Gutters and Downspouts

The gutter/downspout system requires maintenance service. We recommend attention to this important detail.

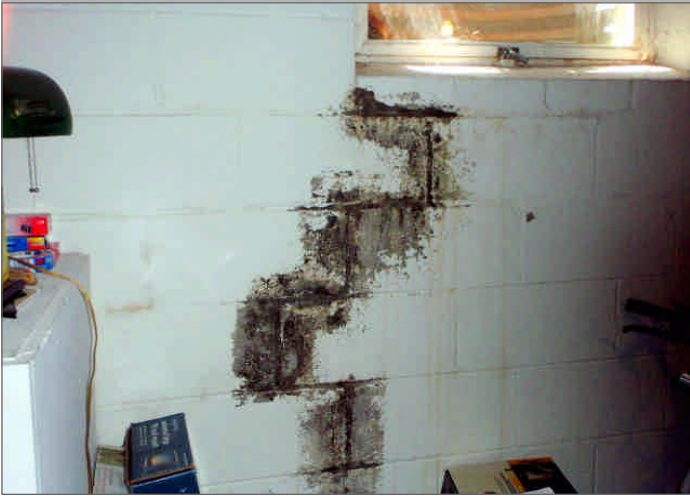
The foundation is in generally acceptable condition where visible. Small cracks, less than 1/4" wide, are not generally considered uncommon or structurally significant. NOTE Some patches/repairs were noted at the front wall. No immediate concerns were noted. We recommend monitoring.

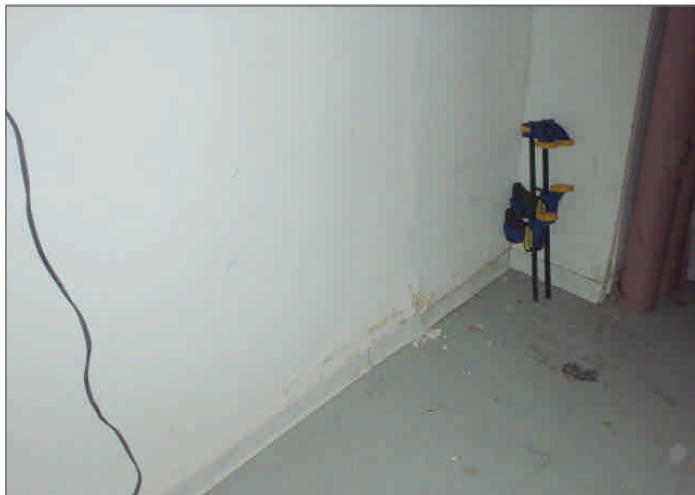
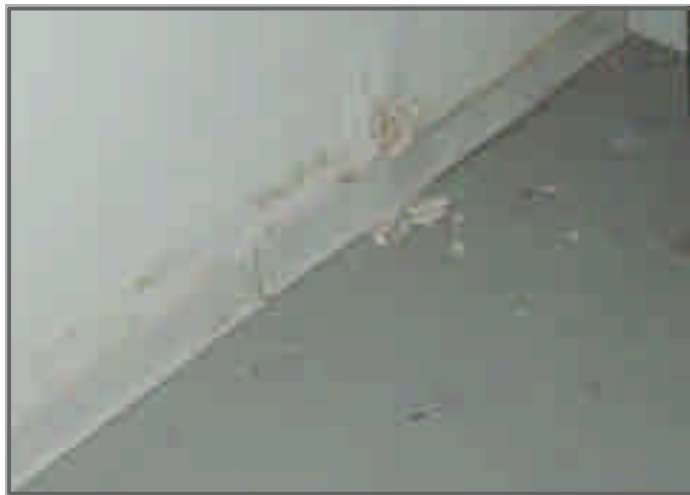
There are moisture stains/minor damage at the drywall surfaces. While there was no evidence of excessive moisture at the time of our inspection, this condition should be discussed with the seller/occupant. If the source has not been determined/eliminated, further review and repairs may be necessary. After satisfactorily verifying no additional moisture intrusion at these areas, the affected surfaces should be refinished. TIP - Before applying finish paint, a coat of a shellac-based primer should be applied to prevent stains from "bleeding"

through.

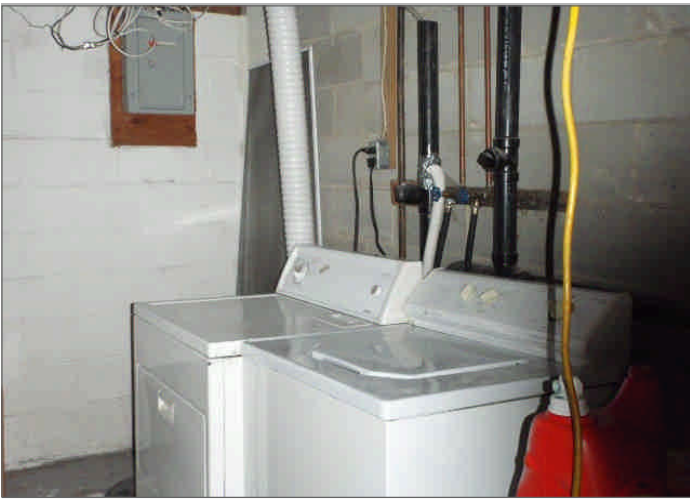
Laundry area photo(s)

The gas dryer vent material is a flexible plastic type which is not permitted for use with a gas dryer We recommend replacing the dryer vent material with smooth-wall metal.

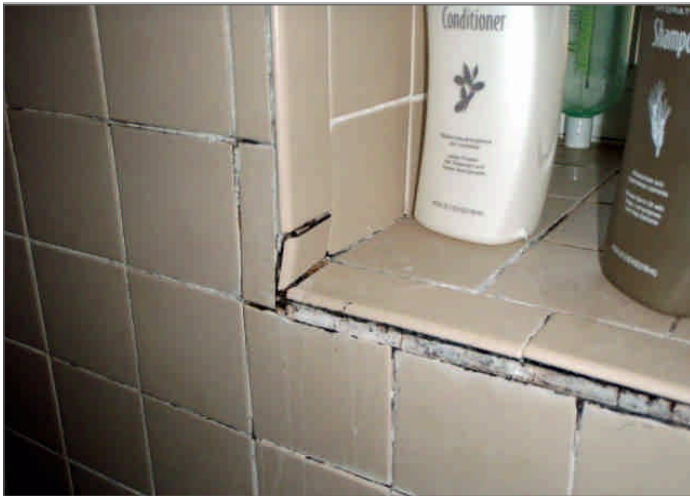
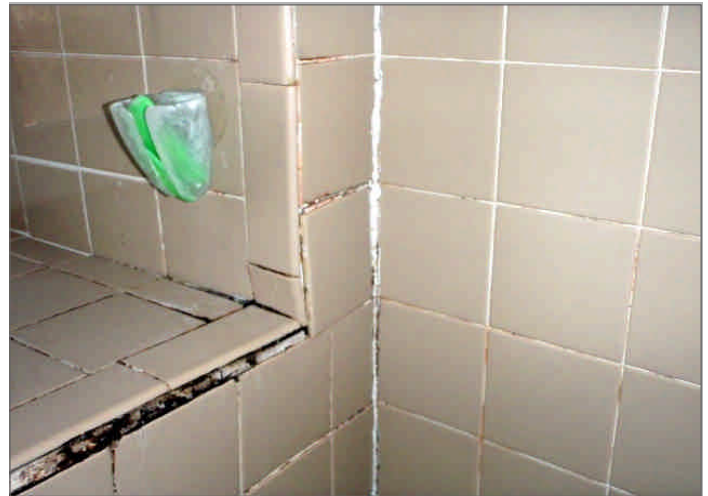
There are damaged/loose tiles at the shower enclosure which should be professionally serviced to prevent moisture entry into the underlying materials. TIP - Underlying materials may already be damaged. The underlying materials should be evaluated for repair or replacement and serviced accordingly as tiles are removed to be re-installed.

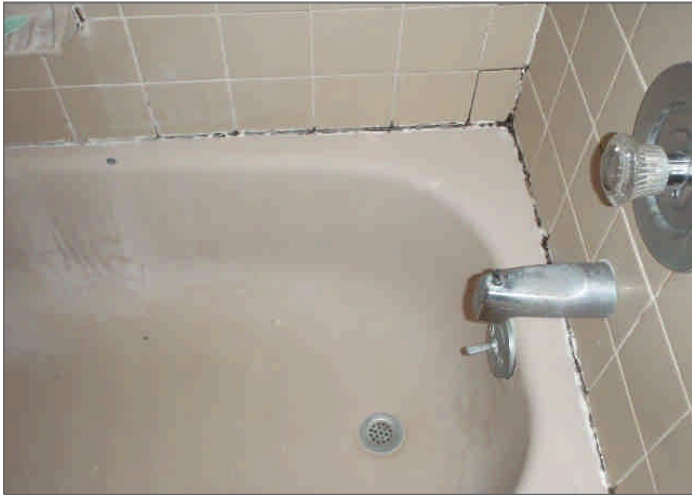
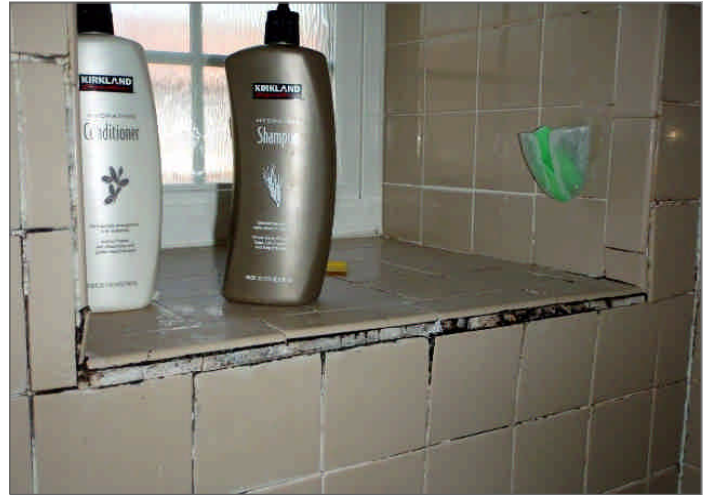
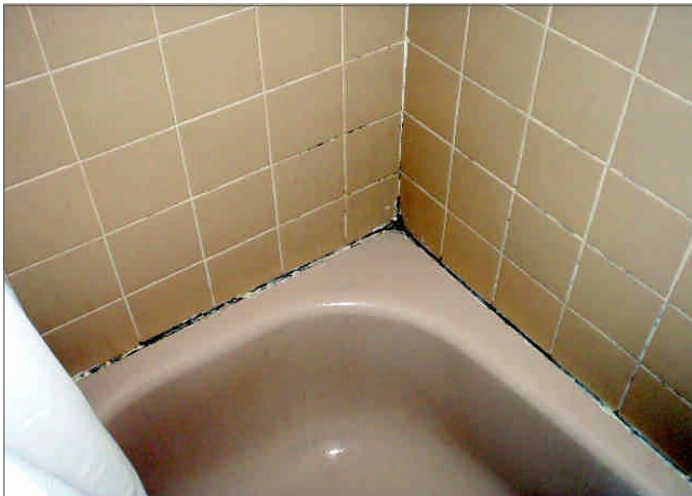
There is an unidentified mold-like growth discovered at Bathroom 2. Mold is a frequently observed condition at areas of moisture intrusion and is not uncommon particularly at areas below grade. As susceptibility and perception of fungal/mold growth differ between individuals, you should pursue this issue to your personal satisfaction. NOTE - You may wish to have further evaluation which is beyond the scope of a home inspection but is offered as an additional service by All Through the House and many other contractors.
